ALTERATIONS AND TESTS OF THE "FARNBORO" ENGINE INDICATOR

By John H. Collins, Jr.
Langley Memorial Aeronautical Laboratory

Washington
September, 1930

TECHNICAL NOTE NO. 348.

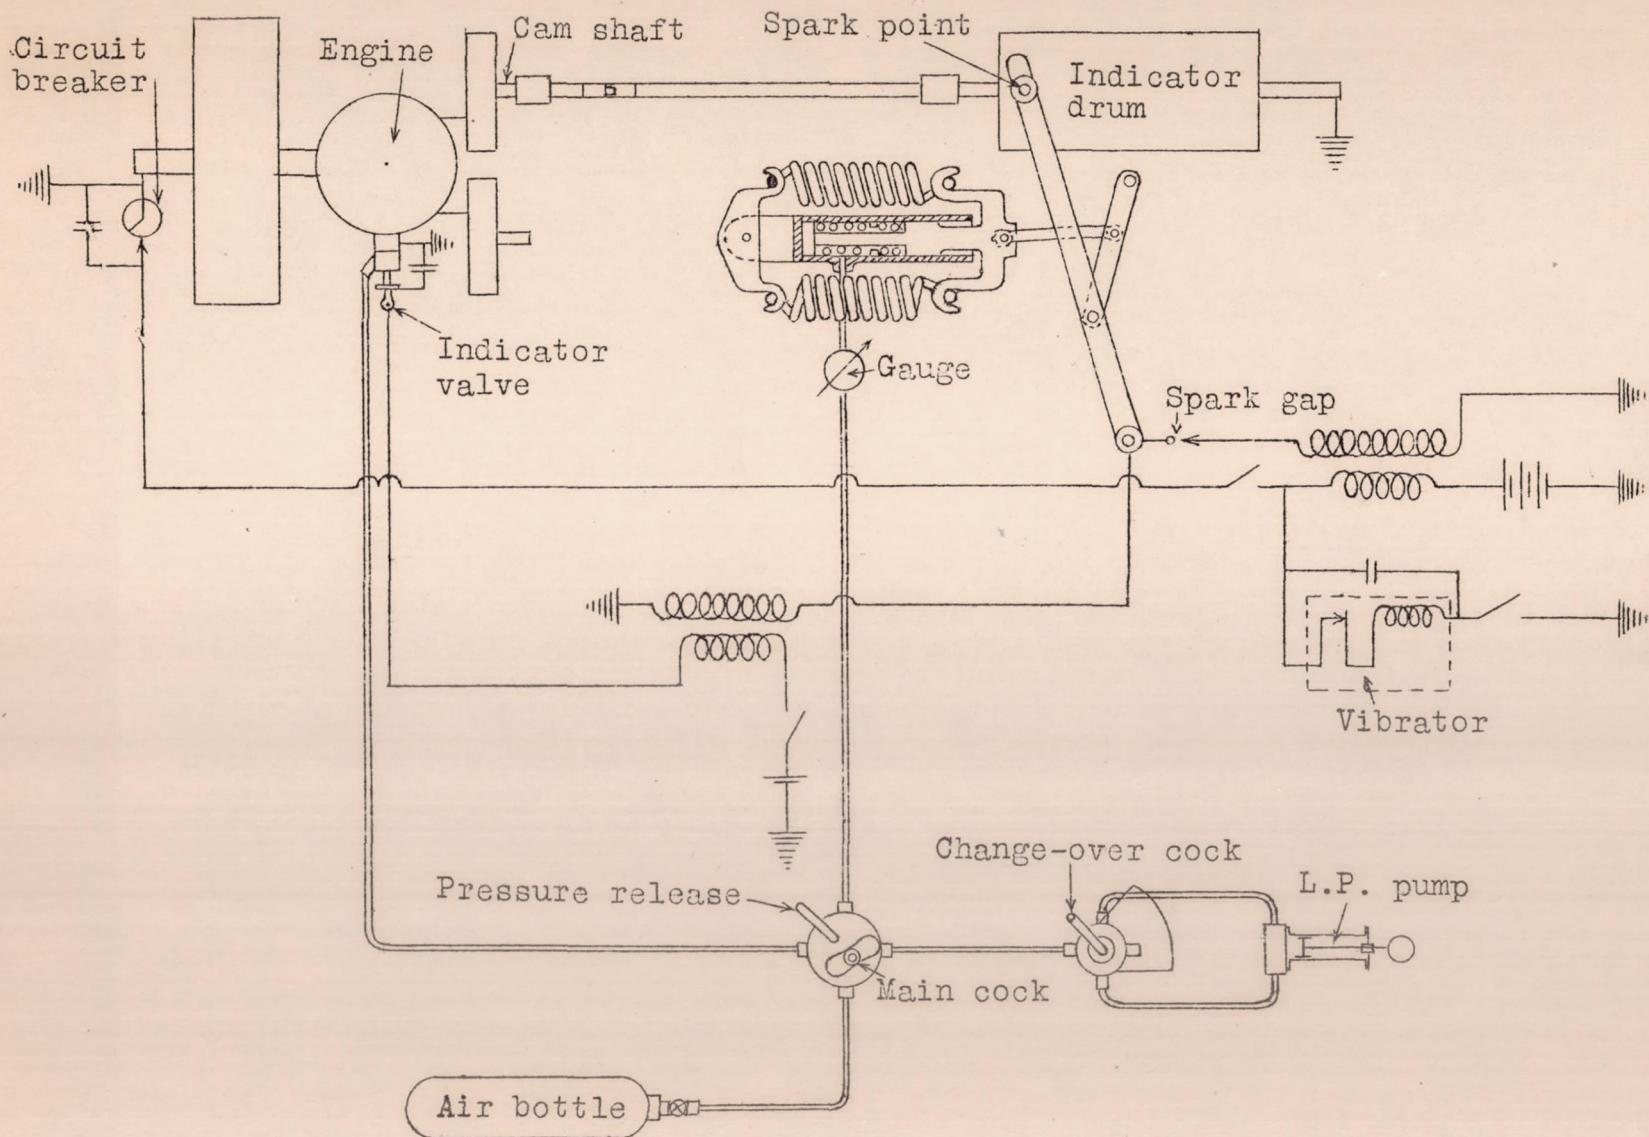
Fig. 1 Diagrammatic sketch of Farnboro indicator with auxiliary circuits.

The same induction coil was used for both the top center line and the pressure lines with the high tension terminal connected directly to the pointer (Fig. 1). This method of completing the circuit resulted in grounding the sparks which indicated the balance points in the engine cycle. To avoid this difficulty, a 1/4 inch gap was left in the high tension line, and since the auxiliary system was operated on 6 volts and the main system on only 2 volts, this gap acted as a one-way electrical valve. There has been no difficulty in operating the various electrical systems using this safety gap.

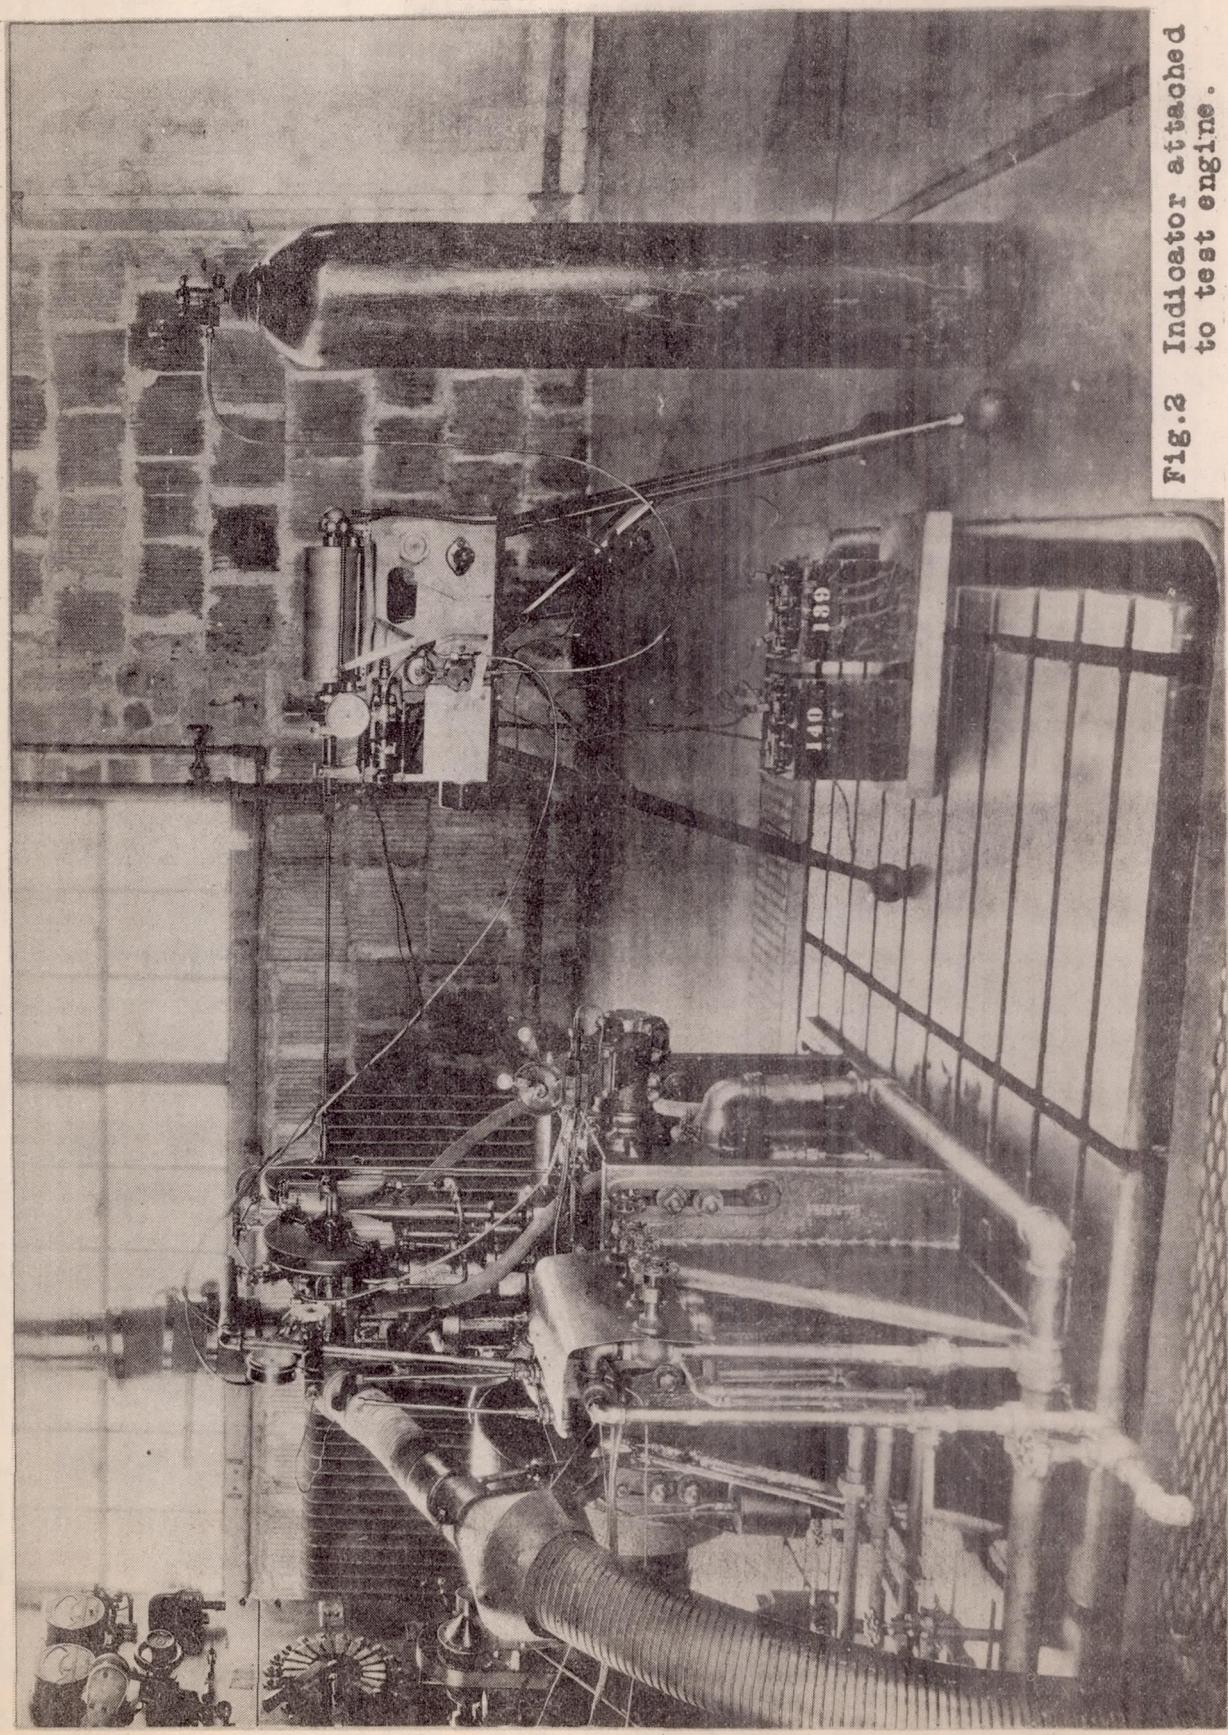
The indicator drum was driven from an extension of the engine cam shaft (Fig. 2). The rigid connection with this shaft caused excessive vibration of the sparking point. To absorb the shocks causing this vibration, one of the universal joints of the drive-shaft was replaced by a short length of rubber hose. The method of driving the drum is an individual problem for each condition of service. In any set-up, the indicator must be free from excessive vibration. The importance of this was clearly demonstrated in these tests, since the dispersion of the points along the lines of the cards was reduced approximately one-half by using the flexible drive-shaft coupling.

Fig.2 Indicator attached to test engine.

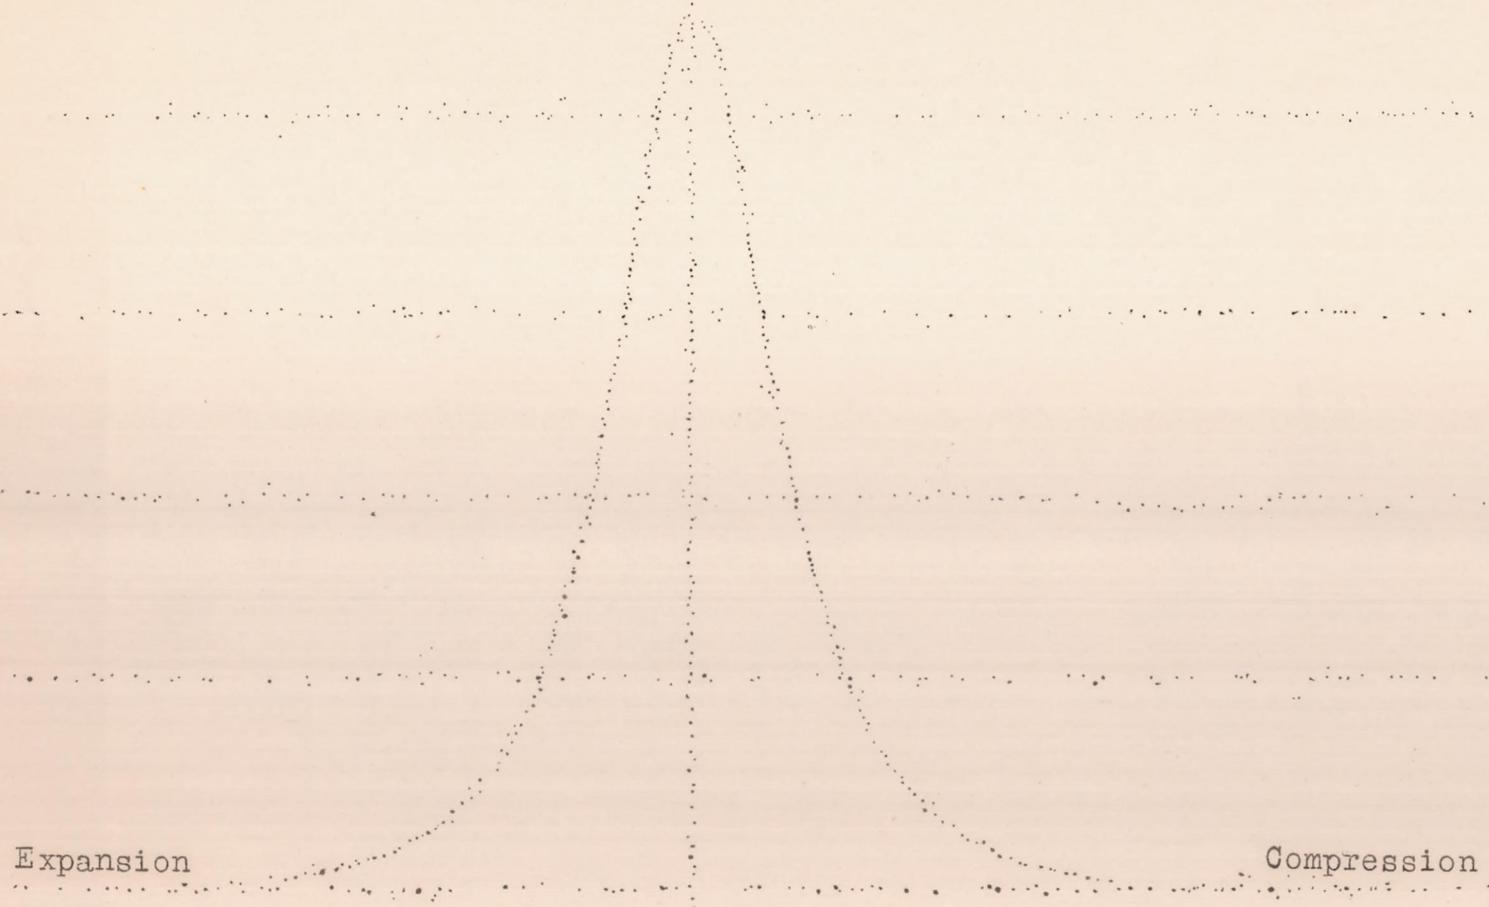
ticed that as the pressure increased, the number of points on the original card diminished, and that for about a 30-degree interval on the expansion line there are no points. An analysis of the cards was made to determine which elements of the indicator required improvement.

Fig. 3 Reproduction of photographs of card taken with indicator as received from manufacturer. Engine motored at 1600 r.p.m. Compression ratio = 13.5.

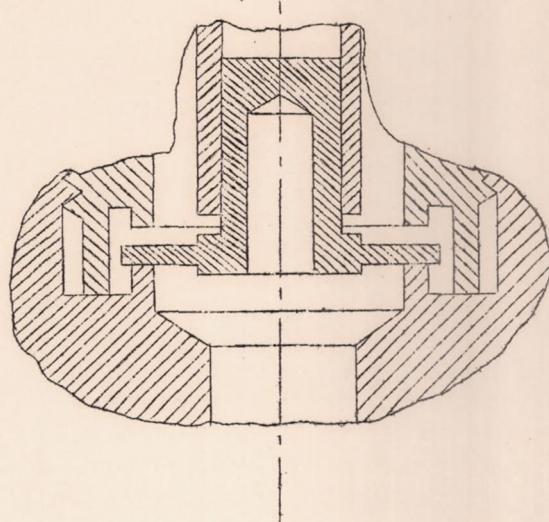
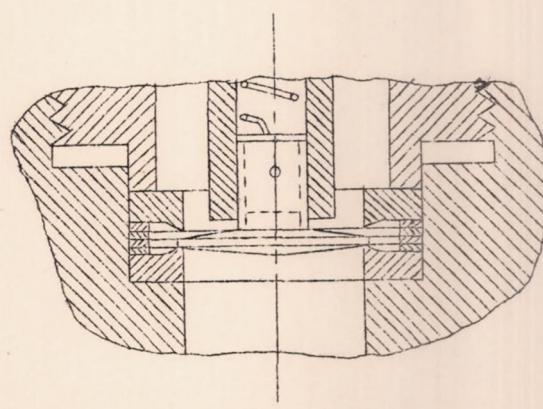
An enlarged view of the original disk and seats as contrasted with the modified design is shown in Figure 5. At a pressure of 700 pounds per square inch, the theoretical differential

pressure required to operate the former was 253 pounds per square inch, while that required for the latter is only 1.5 pounds per square inch. These calculated differential pressures are based on the seat widths of the two designs, which are .034 and .004 inch, respectively. The disk movement of the old design was approximately .0125 inch with no provision for control, while the allowable motion of the new design is within the limits of .004 to .006 inch, and can be readily changed by varying the number of shims between the seats. The weight of the new disk is only 20 per cent of the weight of the original one. This reduction in weight, with its corresponding reduction in the inertia of the moving element, is of great importance in this type of indicator. These three major changes in the design of the actuating unit, weight, travel, and seat area, allow the disk to perform its function in such a short time that the card is complete even at high cylinder pressures and engine speeds. This disk valve has been successfully used to record rates of pressure rise of 1,000,000 pounds per square inch per second, which is about three times that of high-speed carburetor engines.

Fig.5 Enlarged view of original design of disks and seats as contrasted with modified design.

Indicating Unit.— The most serious difficulty found with the apparatus was in the indicating unit, and the trouble seemed localized in its disk and seats. They were, therefore, redesigned so as to reduce the mass of the moving element and decrease its travel. In the original design, the mass and travel of the disk is excessive so that at higher pressures there is not sufficient time between the balance point of compression and expansion for the disk to reach its other seat, or if it does make contact, the coil does not have time to become sufficiently energized to cause a spark at the pointer. A reproduction of the photograph of a card taken with the modified instrument is shown in Figure 4. The line of the record is complete. However, there is a slight decrease in the number of points as the pressure is increased, because the time available for the disk to complete its operation for registering the expansion line becomes so short that all conditions must be favorable for completing the circuit.
